# TECHNICAL SERVICE BULLETIN

No.LTB00477/2012

Land Rover

**Subject/Concern:** Clutch Noise

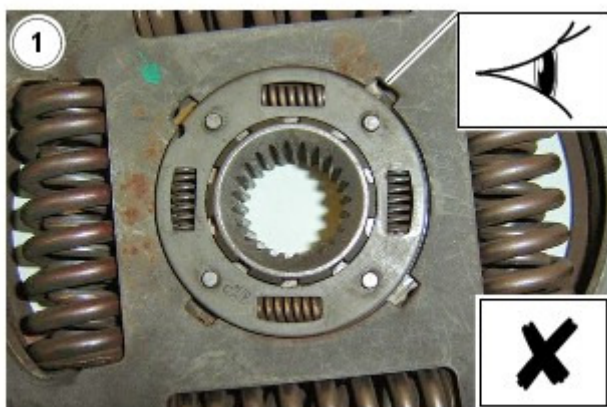
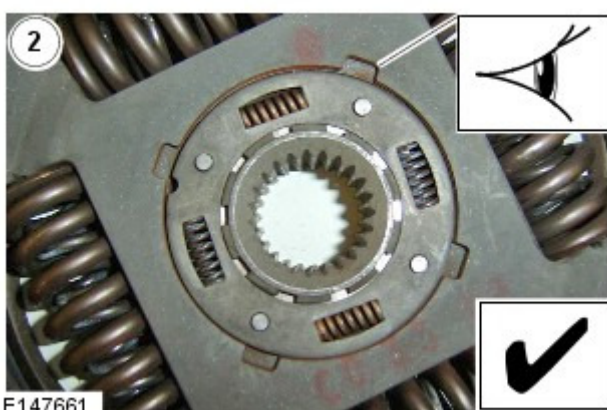
E147661

**Cause:** The thrust washer fitted around the centre hub of the clutch disc may have sheared (this does not cause operation failure of the clutch it generates an audible noise only). **Suggested Customer Concern Code - P24.**

1. Remove the clutch disc and pressure plate (see TOPIx Workshop Manual, section 308-01).
2. Inspect the clutch disc for signs of damage to the thrust washer.
  1. Damaged or missing thrust washer.
  2. Correctly located thrust washer.

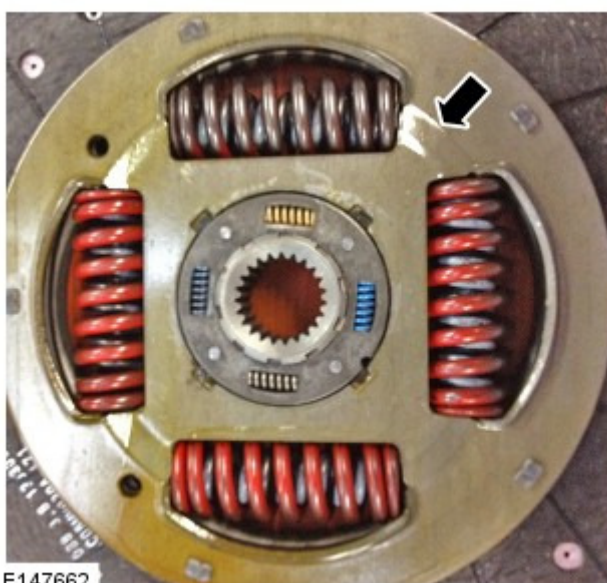
E147662

3. **The new design clutch disc has a gloss finish and a bonded thrust washer.**

Install the new design clutch disc and pressure plate (see TOPIx Workshop Manual, section 308-01).
